North Starr Inspections

15:32PM January 23, 2006

Photo Attachments

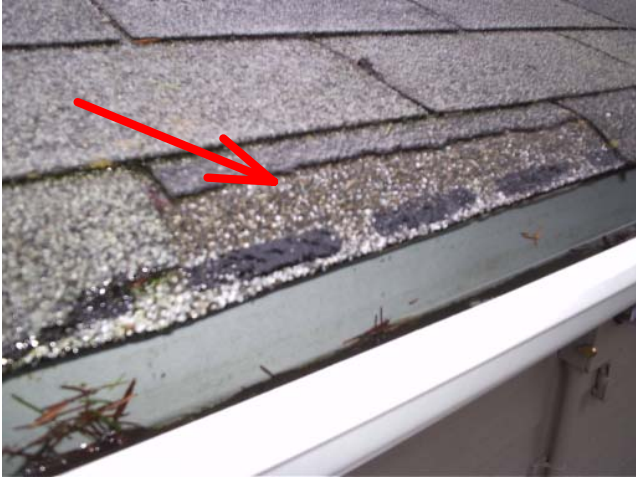
Damaged starter Shingles, back of house

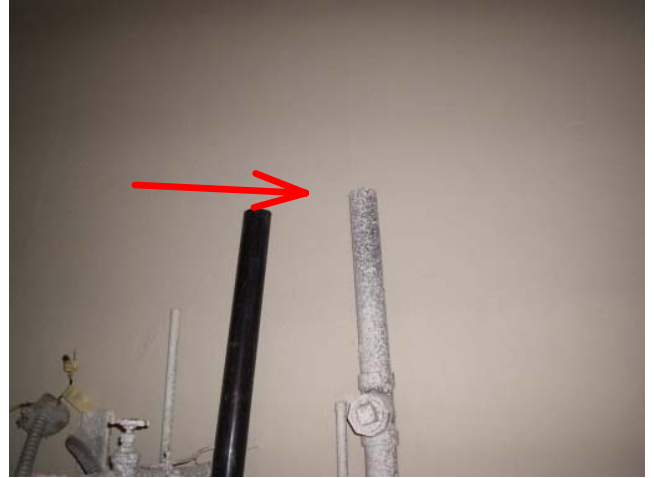
Washer Vent not plumbed thru roof.

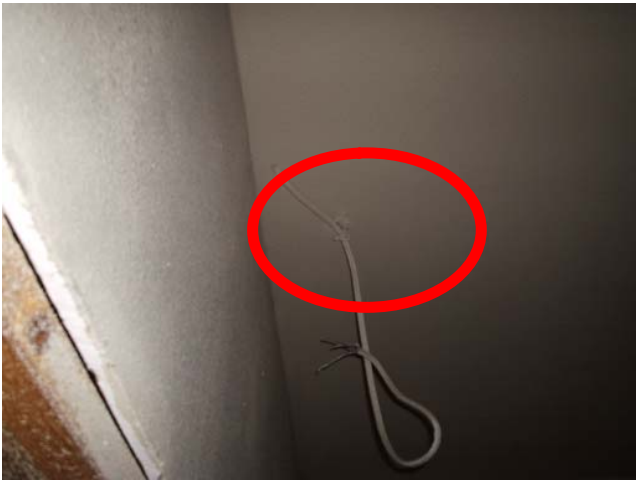
Light missing in laundry room

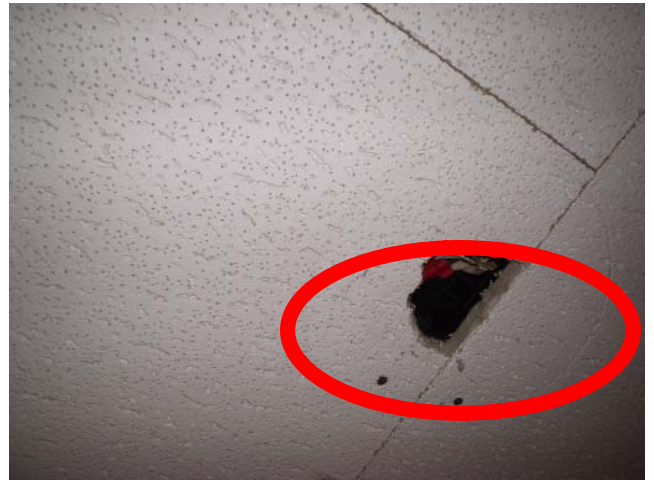
Missing cover on electrical junction box, Great Room

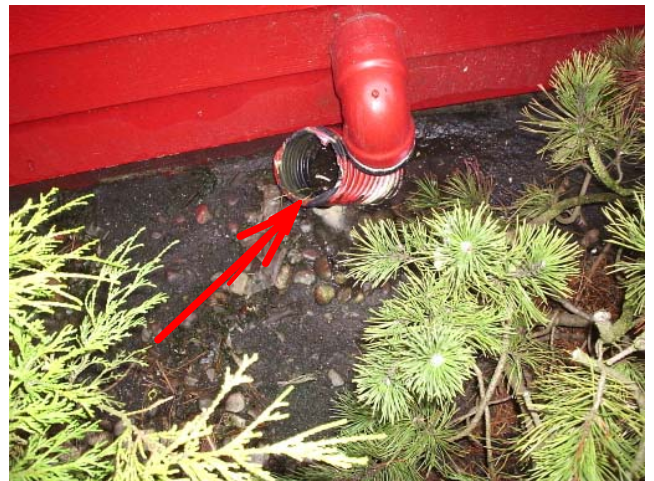
Down spout not connected to Leader, north side of building.
